FTD HIGHRISE INSPECTION INC.

CASE STUDY 14 SPRUCE ST.

SUMMARY

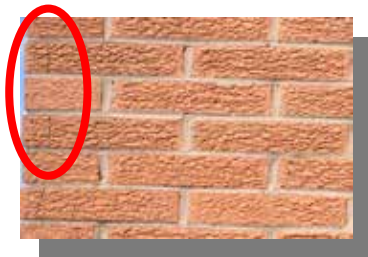
Zoom detail of crack from above photo.

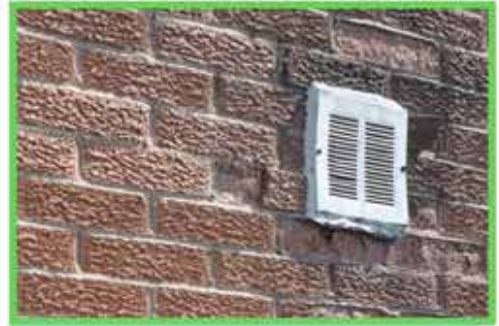
Drop 37 Floor 9 Image 356

Comments: - approximately 20 spalled bricks around exhaust vent grills - localized masonry spalling and efflorescence were also noted at other exhaust vents

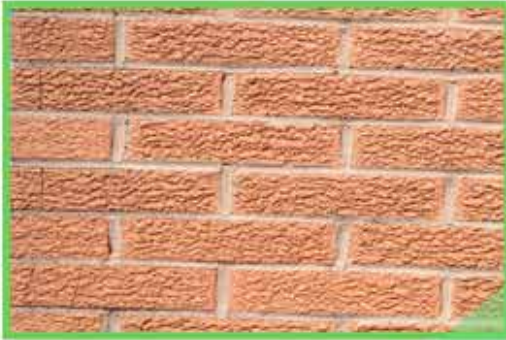
Drop 38 Floor 9 Image 376

- masonry spalling at approximately 4 masonry units

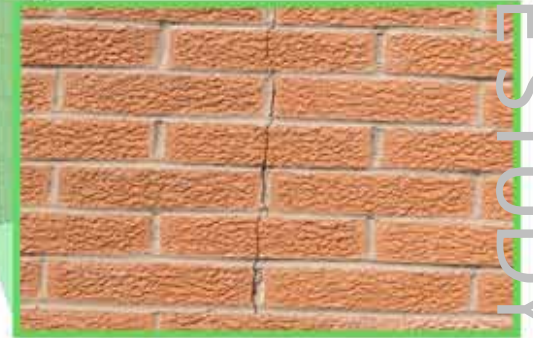
Drop 39 Floor 9 Image 402

- vertical cracking close to wall corners and some step cracking at floor slab edges

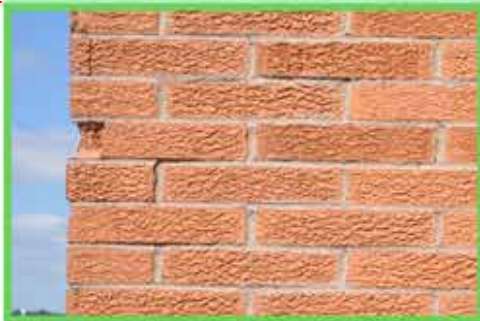
Drop 40 Floor 9 Image 423

- vertical crack below the window corner running through approximately 12 masonry units
