FTD HIGHRISE INSPECTION INC.

Complete building scans using robots.

CASE STUDY 500 AVENUE RD

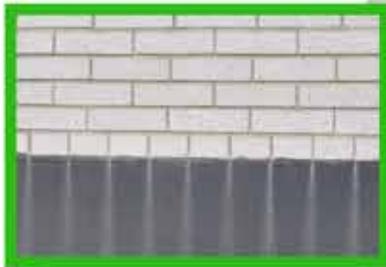
Drop 4 Floor 5 Image 496

- moustache staining at slab edge

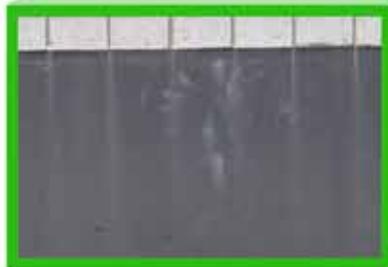
Drop 14 Floor 3 Image 496

- moustache staining at slab edge
